# Manhole Inspection Summary

Manhole # S21MM\_012MH

Insp Date: **6/29/07 10:41 AM**

**Location** Address: **2201 FULTON AVE**

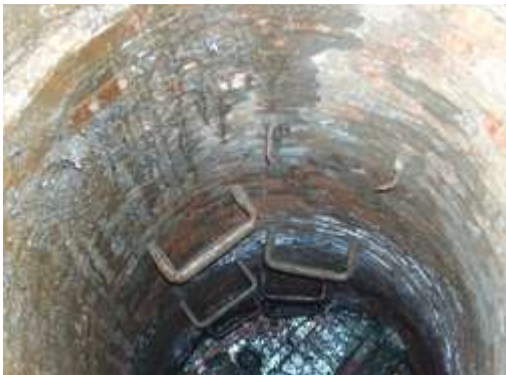
Defect 3

Count: **6** Missing: **2** ☒ **Corroded**

MISSING AND CORRODED STEPS

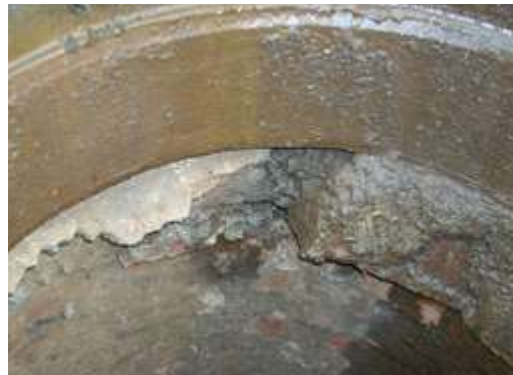
Defect 2

Condition: ☐ Sound ☐ Cracked ☐ Root Intrusion ☐ Loose Brick ☒ **Deteriorated**

DETERIORATION OF CHIMNEY

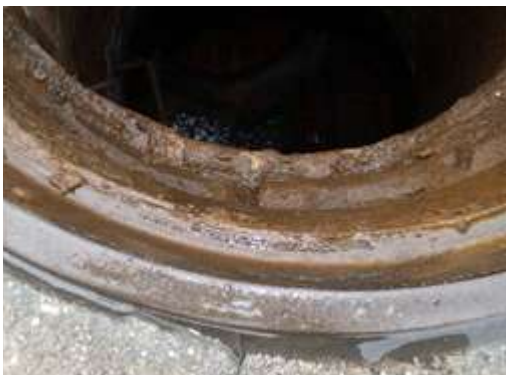
Defect 1

Offset: **3** (in.)

FRAME OFFSET

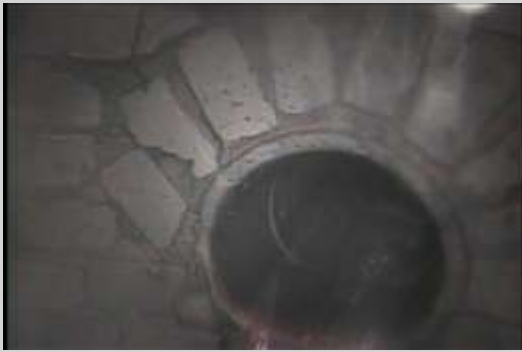
9 O'Clock Inflow

Drop Condition: **Partly Clogged**
